Produce acetylene in Croatia

PROBLEMS

WORKING STEPS

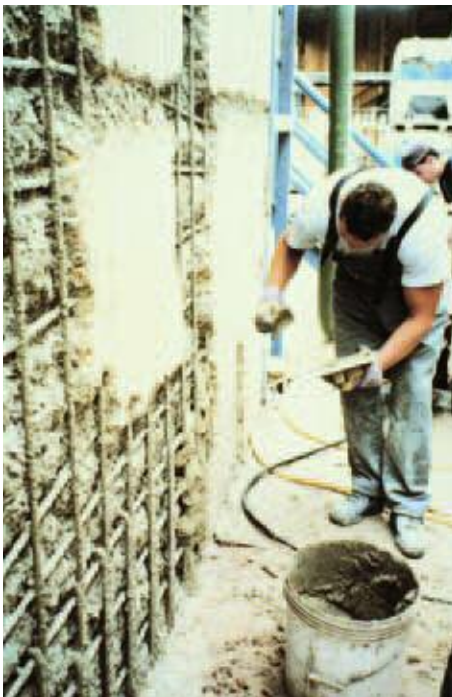
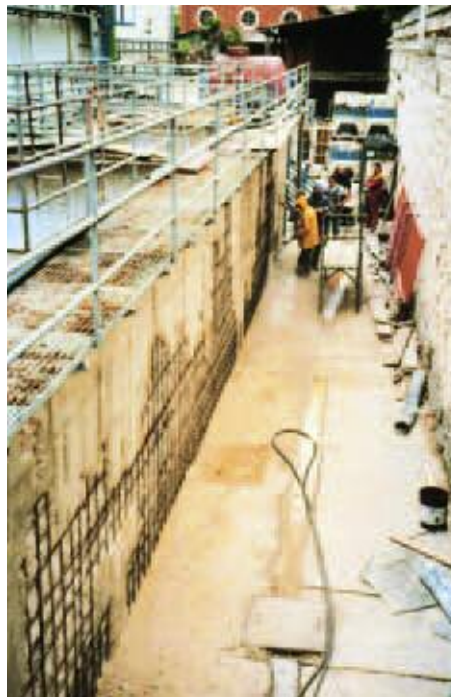
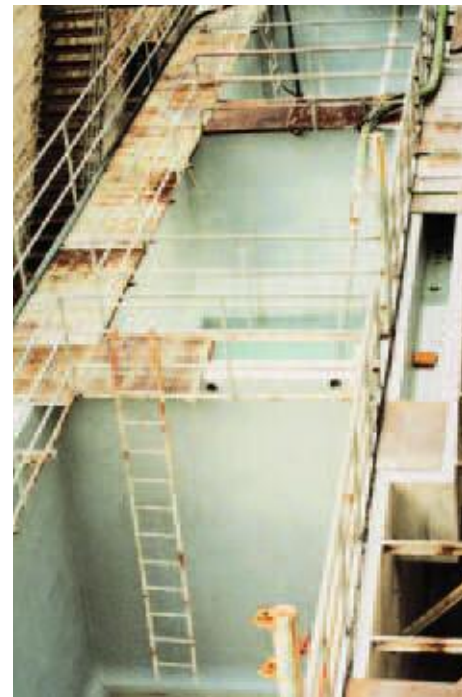
There is an acetylene production facility located inside the shipyards in the Croatian town of Pula. The facility has tanks containing the products which when combined produce acetylene, a gaseous hydrocarbon which burns with a bright flame. The tanks were showing signs of serious degradation.

The inevitable ageing process to which all constructions are subject over time, the negative effects of atmospheric agents, aggravated by the high salt concentration due to the proximity of the facility to the sea, and also the lack of routine maintenance, had all assisted in the deterioration of the reinforced concrete structure, which was by this stage at an advanced level. Large sections of cladding had already become detached and the reinforcement bars were already affected by the consequent oxidation process.

The damaged sections of concrete were removed until the reinforcement bars were fully exposed. The latter were then subject to a thorough process of wet sand-blasting (at 300 bar pressure). They were then coated in Antol Ripristino Fondo, a two-component cement-resinous grout providing corrosion resistance, particularly necessary given the proximity of the facility to the sea.

Once this protective layer had hardened, the anchoring rendering had to be applied. This consisted of a liquid mix of Antol Restauro, a fibre-reinforced resin-bonded mortar, with a 1:2 solution of Neoplast Latex, a special resin-based fixing adhesive. The volumetric repair was then made using Antol Restauro, which amongst other things hardens very rapidly. Antol Aquaproof, a ready-to-use water-proofing mortar, mixed together with the modifying agent, Neoplast Latex was then applied to protect, finish and water-proof the external surfaces of the tanks containing the reaction products. The concrete on the inside of the tanks also had to be protected against the chemical effects of the reaction agents used in the production of acetylene. These surfaces were treated with Emulsione Epossidica 723, an epoxy-resin two-component paint emulsified in water.
