# Ripristino

## L'Ottagono

## Repairing the Ottagono

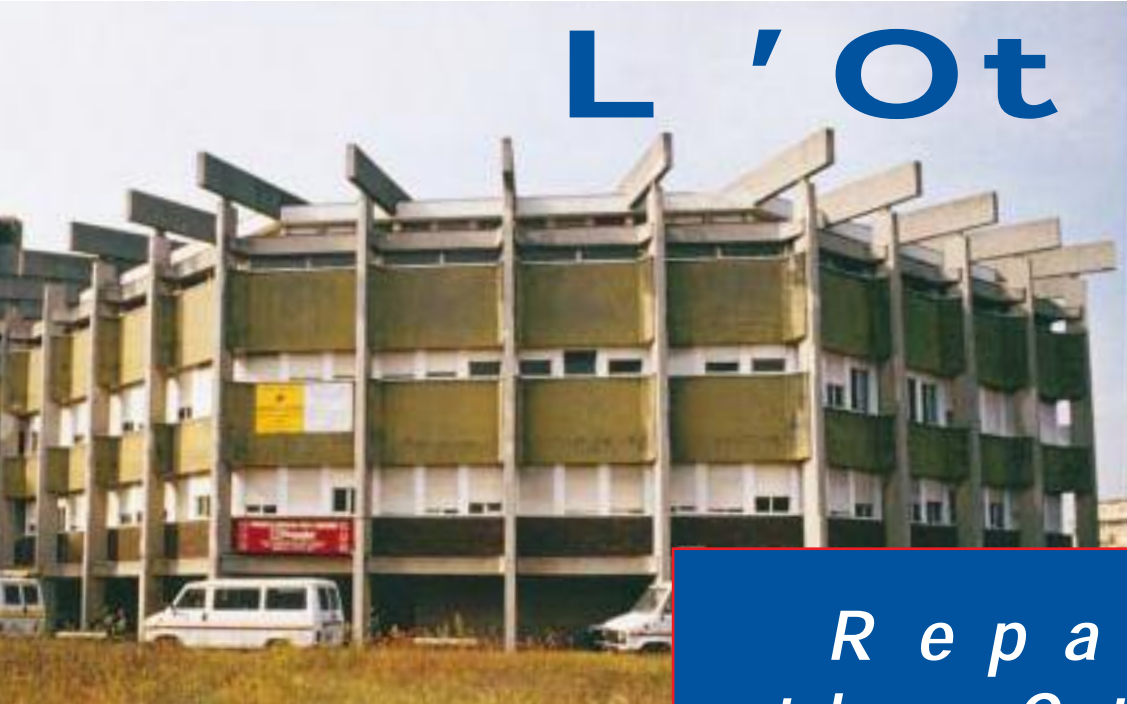
*“Ottagono” is the term used to identify the building which houses the group of operating theatres in the Rimini Local Health Authority Hospital*

*complex. The building, linked to the main hospital building, is octagonal and has reinforced concrete load bearing framework and perimeter*

“Ottagono” è il termine utilizzato per identificare la struttura che ospita il gruppo delle sale operatorie del complesso ospedaliero dell’Azienda Sanitaria Locale di Rimini, perché ottagonale è la pianta dell’edificio, collegato al corpo centrale del fabbricato, costituito da elementi portanti in cemento armato e tamponature perimetrali; realizzato tra la seconda metà degli anni Sessanta e i primi anni del Settanta. Il blocco è scandito perimetralmente da una serie di 32 pilastri intonacati, collegati all’estremità superiore ad altrettante travi, disposte radialmente, che sostengono la copertura. Nella struttura erano visibili evidenti segni di degrado dovuto alla carbonatazione dei copriferri. Fratture e distacchi superficiali avevano attivato lo sviluppo dell’ossidazione dei ferri di armatura ormai affioranti e completamente arrugginiti. Affinché il processo innescato non progredisse fino a compromettere la validità statica dell’edificio è stato prescritto un intervento di recupero conservativo che prevedesse l’utilizzo di un sistema di ripristino del calcestruzzo in grado di affiancare agli effetti benefici delle moderne resine, come l’elevata resistenza alla diffusione dell’anidride carbonica, i vantaggi dei sistemi cementizi che garantiscono traspirabilità al vapore acqueo, resistenza a flessione e compressione e compatibilità con la struttura preesistente: il sistema Antol Ripristino.

*curtain walls. It was built between the second half of the 1960s and the start of the 1970s. The block is marked along the perimeter by a series of 32 plastered pillars, connected at the top and the same number of crossbeams, arranged radially, which support the roof. The structure had clear signs of degradation due to the carbonation of the reinforcement bar protections. Surface cracks and crumbling had led to the oxidation of the protruding and completely rusted reinforcement bars. To prevent this process from endangering the stability of the building, it was decided to go ahead with repairs involving the use of a concrete restoration system which combined the advantages of modern resins, (e.g. high resistance to carbon dioxide diffusion), with the advantages of concrete systems which guarantee water vapour transpiring, resistance to flexion and compression and compatibility with the existing structure. The system is known as Antol*

La procedura di intervento ha avuto inizio con la rimozione delle porzioni di calcestruzzo ammalorate e l'eliminazione, attraverso l'idropulitura delle superfici, di patine superficiali incoerenti, lattime di cemento e ruggine. La prova alla fenolftaleina, eseguita subito dopo la pulizia del supporto per rilevare lo stato di carbonatazione del conglomerato, evidenziava come il grado di alcalinità raggiunto in seguito alla fase di preparazione fosse idoneo alle operazioni di ripristino. Spazzolati e sabbati a metallo bianco, i ferri sono stati trattati con una prima mano di Antol Ripristino Fondo, un prodotto anticorrosivo bicomponente, costituito da una miscela di cemento e cariche speciali e da polimeri in dispersione acquosa dotati di elevata capacità di resistenza alla diffusione dell'anidride carbonica. Per la duplice azione che il prodotto è in grado di svolgere, cioè la protezione anticorrosiva e l'adesione delle successiva malta di riporto, dopo due ore dalla prima applicazione è stata passata una seconda mano di fondo, questa volta anche sul calcestruzzo circostante, come prespalmatura di aggrappo. Sulla seconda mano ancora fresca è stato applicato uno strato di Antol Ripristino Malta, una malta bicomponente per il ripristino volumetrico costituita da una miscela di cementi speciali, fibre, inerti e additivi e da polimeri pregiati in dispersione acquosa. Nelle parti in cui lo spessore del riporto superava i 3 centimetri, è stato utilizzato Antol Restauro,

The procedure started with the removal of the damaged portions of concrete and the elimination, by cleaning the surfaces with water, of all crumbly, loose and rusty surface material. The phenolphthalein test, carried out immediately after the cleaning of the support to measure the state of carbonation in the conglomerate, showed how the level of alkalinity reached after the preparation stage was ideal for the commencement of restoration. Brushed and sanded down, the bars were treated with a first coat of Antol Ripristino Fondo, a two-component corrosion-proofing product, consisting of a mix of cement and special additives and polymers in a water solution with high resistance to the diffusion of carbon dioxide. As the product has a twin action, namely corrosion-proofing and adhesion to the next repair mortar, two hours after the first coat, a second coat was applied, this time also to the surrounding concrete, as a preliminary gripper coat. While the second coat was still fresh, a layer of Antol

Ripristino Malta was applied. This is a two-component mortar for volumetric repairs consisting of a mix of special cements, fibres, inert agents and additives and special polymers in a water solution. Where the thickness of the repair exceeded 3 centimetres, Antol Restauro was used, a resin-bonded, fibre-reinforced, thixotropic, highly-adhesive mortar which permits, thanks to its setting speed, a considerable reduction in the time required for each stage of the process. The elements involved in the operation were treated with Mastofix S Grigio, a powder adhesive. A reinforcement mesh immersed in the Mastofix S Grigio. After 24 hours, Antol Ripristino Rasante, a fine two-component smoothing mortar with high resistance to the diffusion of carbon dioxide was applied. In order to protect the structures against the action of sulphur dioxide and saline solutions in order to achieve the maximum resistance to carbon dioxide diffusion, about 15 days after the application of the smoothing compound, the elements were treated with Antol Promural Acryl, a pure acrylic-resin based single-component paint in a water solution.
