Moisture in the country

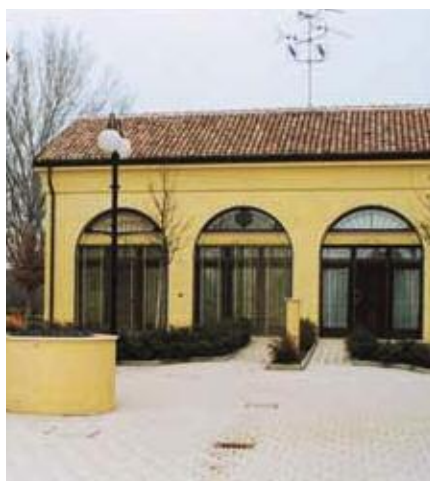
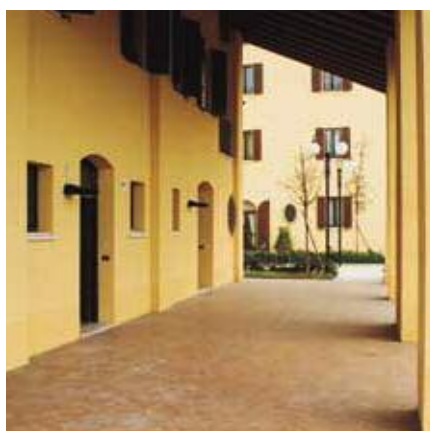
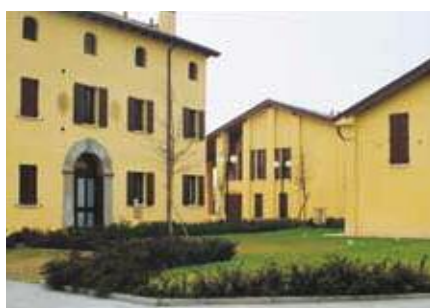
Le murature in laterizio si presentavano in stato di avanzato degrado, provocato principalmente dalla risalita dell'umidità dal terreno e dalla perdita di efficacia dei rivestimenti originari. Erano inoltre presenti diffuse efflorescenze saline, principalmente di natura organica: nitrati, causati soprattutto dalla presenza degli animali.

The brick walls had seriously degraded, which was principally caused by moisture rising from the soil and by the reduced effectiveness of the original wall coverings. Also, saline blooming mainly of organic origin was widespread and consisted of nitrates that had mostly been deposited by animals.

Per risolvere il problema dell'umidità si è deciso di intervenire con il ciclo Antol Risan, che grazie all'impiego di un intonaco fortemente traspirante e altamente idrorepellente rappresenta un metodo semplice e definitivo per il risanamento delle murature umide. Grazie all'effetto "spugna" (cioè la capacità di attirare l'umidità contenuta nel muro e cederla rapidamente all'aria) l'intonaco mantiene le superfici asciutte, libere da efflorescenze e muffe.

Sulla muratura completamente liberata dai vecchi rivestimenti è stata applicata un'abbondante mano di Antol Antisale Universale, un prodotto a base di resine silano-silossaniche in dispersione acquosa in grado di formare una barriera temporanea contro i sali che l'acqua veicola dal terreno o dalla stessa muratura sulla superficie, dove si depositano formando le caratteristiche efflorescenze. Tale barriera ha lo scopo di impedire ai sali di penetrare nel successivo strato di intonaco, durante la sua fase plastica. A distanza di 24 ore si è proceduto a realizzare il rinzafo di aggancio, applicando Neoplast Latex miscelato con cemento e sabbia e diluito con acqua. Si tratta di un adesivo di presa a base di resine speciali che presenta una resistenza molto elevata alla saponificazione e all'azione dell'acqua e altrettanti proprietà adesivizzanti, che ottimizzano il contatto fra la muratura e l'intonaco di risanamento Antol Risan. Quest'ultimo è stato applicato in spessore di 2 centimetri sul rinzafo rassodato; essendo una malta premiscelata, a base di cemento e sabbia di quarzo, agenti aeranti e resine adesivizzanti e idrofobizzanti, è in grado di prosciugare i muri invasi da umidità di risalita e impedire la formazione di efflorescenze e muffe. La finitura è stata eseguita all'interno con pitture a calce.

To solve the problem of moisture, the Antol Risan treatment cycle was used. Thanks to the use of a water-repellent plaster that can "breathe" properly, this method is simple and conclusive for restoring walls that have been attacked by water. Thanks to their "sponge" effect (that is, the capacity for capturing moisture contained in the wall and then releasing it rapidly into the air), the plaster keeps the surfaces dry and free from blooming and mould. After the old covering had been completely removed from the walls, a generous coat of Antol Antisale Universale salt barrier was applied. This product, which contains xylano-siloxanic resins in aqueous suspension, forms a temporary barrier against the salts that water transports up from the soil or from the wall itself to its surface, where they are deposited as characteristic blooming. The purpose of the barrier is to prevent salts from penetrating the overlying layer of plaster for the entire period of time required for it to cure. 24 hours after the product was applied, a scratch coat was laid down using Neoplast Latex mixed with cement and sand, and diluted with water. This is a gripping adhesive employing special resins that offer remarkably high resistance to saponification and to the action of water, as well as adhesion-promoting properties which optimize contact between the wall and the Antol Risan renewal plaster. The latter material was applied in a thickness of 2 centimetres on the stiffened scratch coat. Since Antol Risan is a premixed mortar containing cement and quartz sand, aeration agents, and resins that are adhesion-promoting and hydrophobic, it dries up walls attacked by rising moisture and prevents the formation of blooming and mould. Interior walls were finished using lime-based paints.
