# L'ex convento di San Giacomo Apostolo a Forlì

## LE PROBLEMATICHE

## The former convent of San Giacomo Apostolo at Forlì

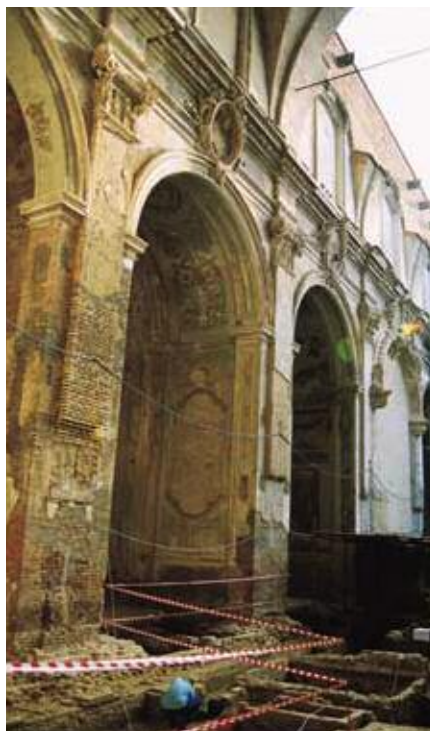
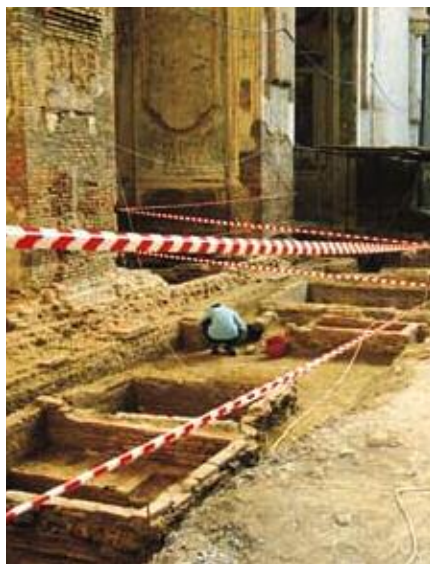
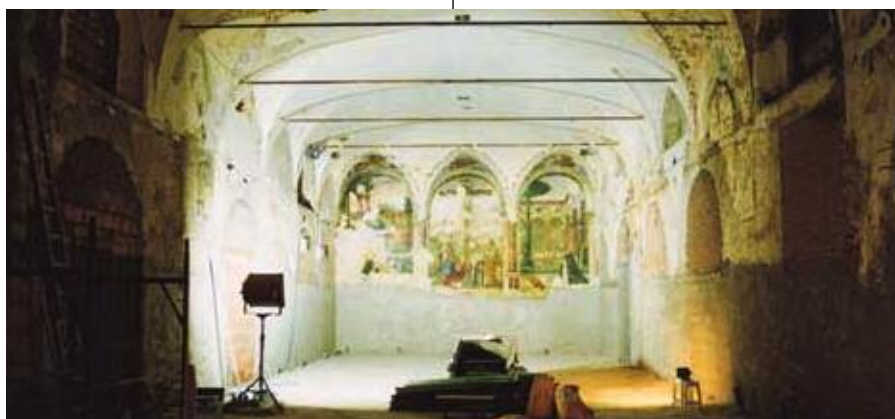
Parte delle murature in laterizio erano soggette a importanti risalite di umidità, che avevano provocato la distruzione degli intonaci di rivestimento, delle decorazioni in stucco e delle superfici affrescate fino a un'altezza di circa 2 metri dal piano di calpestio.
