Produce acetylene in Croatia

PROBLEMS

WORKING STEPS

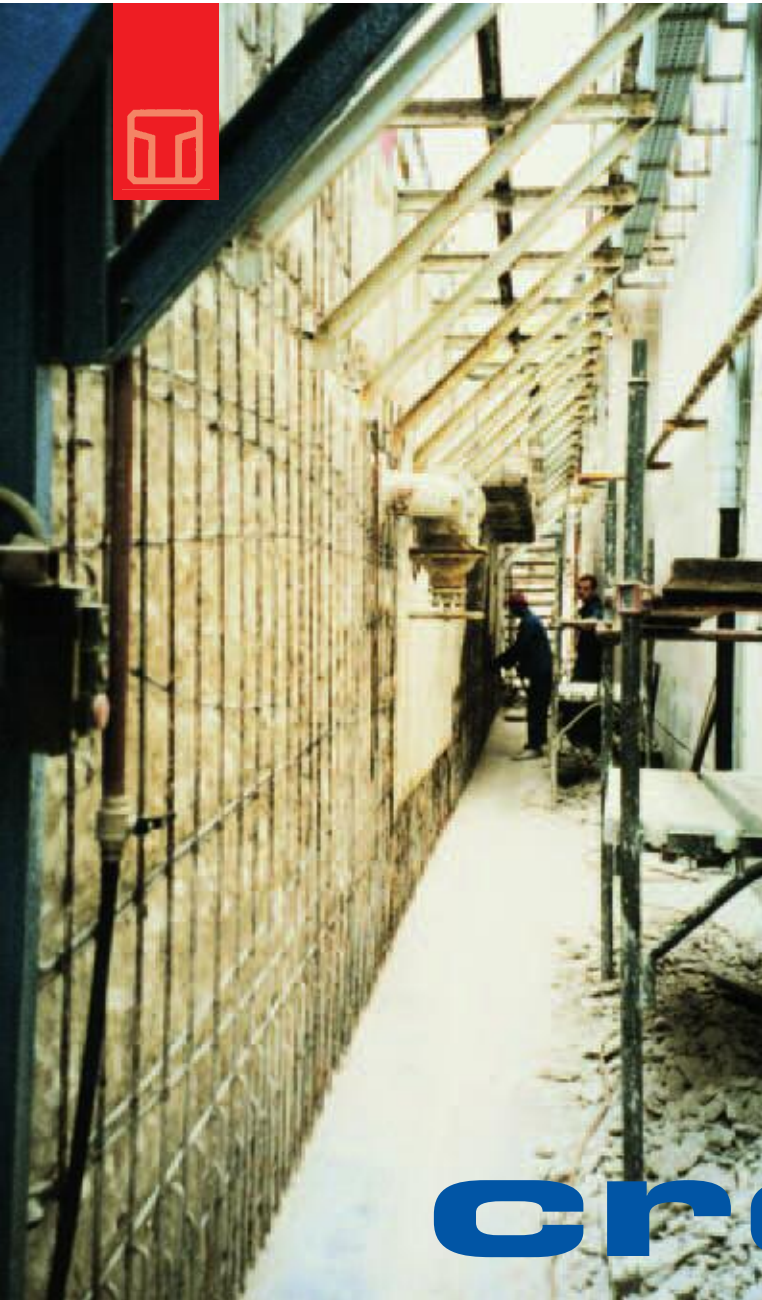
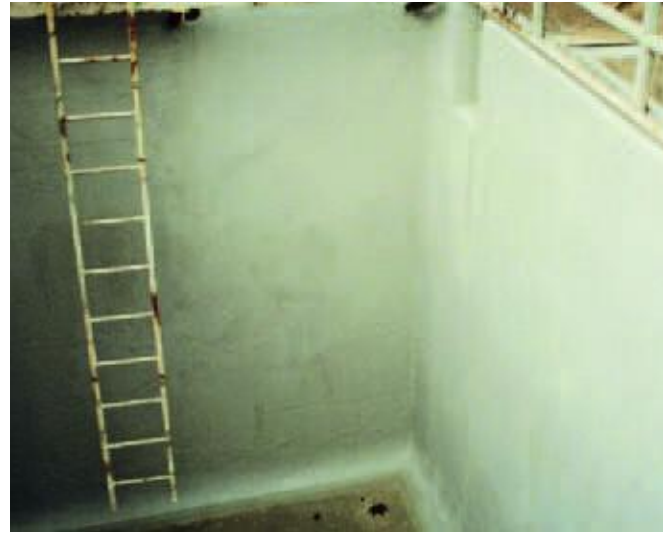
There is an acetylene production facility located inside the shipyards in the Croatian town of Pula. The facility has tanks containing the products which when combined produce acetylene, a gaseous hydrocarbon which burns with a bright flame. The tanks were showing signs of serious degradation.

The inevitable ageing process to which all constructions are subject over time, the negative effects of atmospheric agents, aggravated by the high salt concentration due to the proximity of the facility to the sea, and also the lack of routine maintenance, had all assisted in the deterioration of the reinforced concrete structure, which was by this stage at an advanced level. Large sections of cladding had already become detached and the reinforcement bars were already affected by the consequent oxidation process.

The damaged sections of concrete were removed until the reinforcement bars were fully exposed. The latter were then subject to a thorough process of wet sand-blasting (at 300 bar pressure). They were then coated in Antol Ripristino Fondo, a two-component cement-resinous grout providing corrosion resistance, particularly necessary given the proximity of the facility to the sea.

Once this protective layer had hardened, the anchoring rendering had to be applied. This consisted of a liquid mix of Antol Restauro, a fibre-reinforced resin-bonded mortar, with a 1:2 solution of Neoplast Latex, a special resin-based fixing adhesive. The volumetric repair was then made using Antol Restauro, which amongst other things hardens very rapidly. Antol Aquaproof, a ready-to-use water-proofing mortar, mixed together with the modifying agent, Neoplast Latex was then applied to protect, finish and water-proof the external surfaces of the tanks containing the reaction products. The concrete on the inside of the tanks also had to be protected against the chemical effects of the reaction agents used in the production of acetylene. These surfaces were treated with Emulsione Epossidica 723, an epoxy-resin two-component paint emulsified in water.
